Docket No. 217 – Development and Management Plan Inspection

Northeast Utilities Service Company Certificate of Environmental Compatibility and Public Need for the construction of a 345-kV electric transmission line and reconstruction of an existing 115-kV electric transmission line between Connecticut Light and Power Company's Plumtree Substation in Bethel, through the towns of Redding, Weston, and Wilton, and to the Norwalk Substation in Norwalk, Connecticut.

Date: January 12, 2006

Location: 115 kV Underground Route

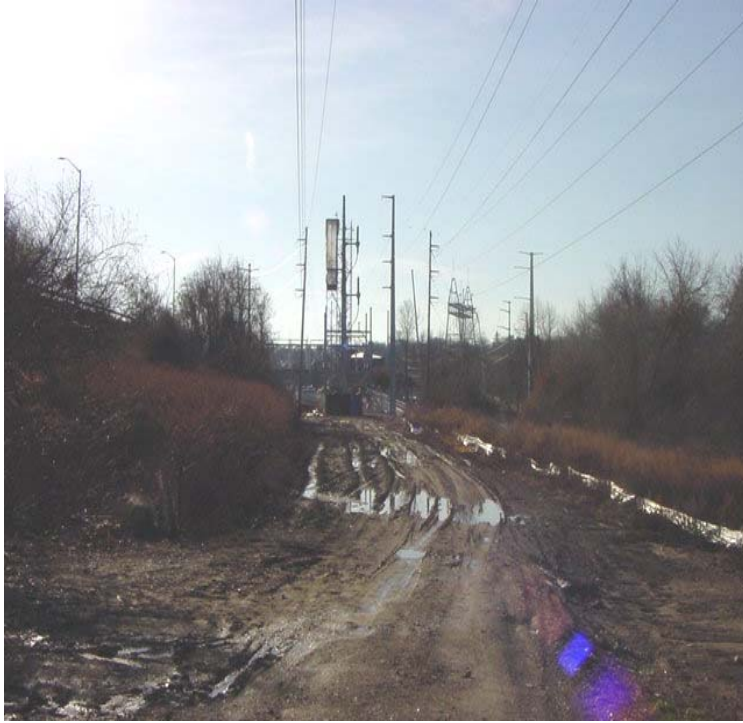
| Areas of Inspection | Observation | Recommended Action |
|---|--|--|
| | - Work on the structure near the substation was complete and scaffolding was to be removed soon. 1/12/06 | - See erosion control section for specifics. 1/12/06 |

115kV (ROW and Norwalk Junction): Photo on the left shows a view of the structure adjacent to the Norwalk substation. Photo on the right shows a view of the structure at Norwalk Junction. Work was mostly and scaffolding was to be removed from both. 1/12/06

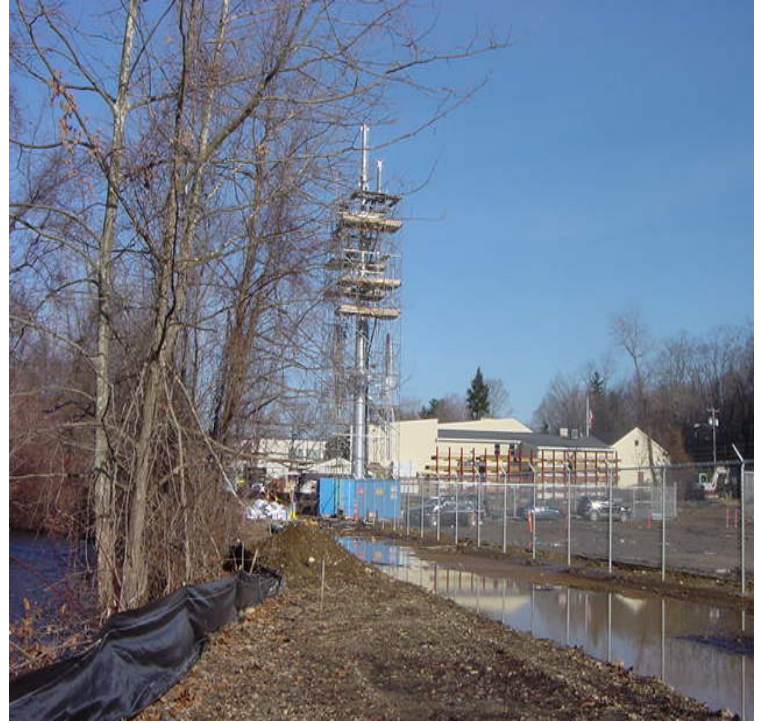
| Areas of Inspection | Observation | Recommended Action |
|---|--|--|
| Main Ave. / Rt. 7, Norwalk | -115kV work associated with the structure at Norwalk Junction is finishing up as scaffolding is disassembled. 1/12/06 | - Coordinate snow plowing issues (when necessary) with other contractors . 12/14-1/12/06 |

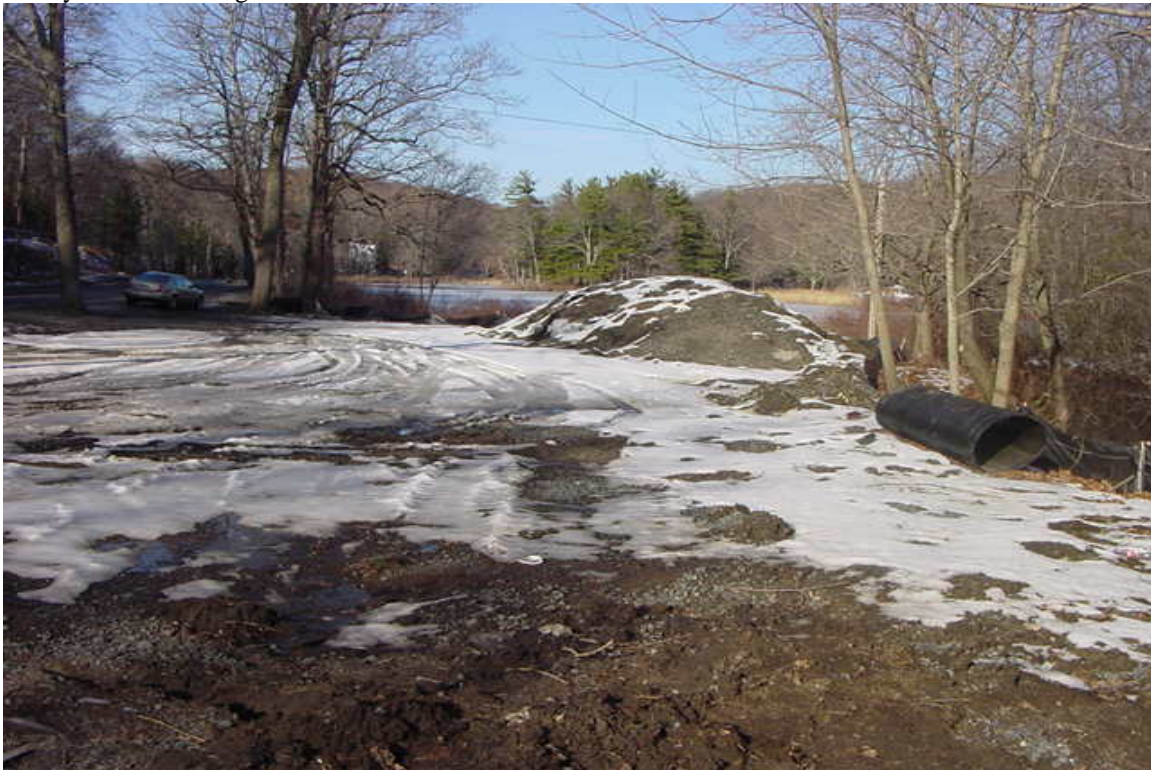
| Areas of Inspection | Observation | Recommended Action |
|---|--|--|
| | - The silt fence at the Putnam Park storage area was righted and the snow piles were pulled back. 1/12/06 | - None at this time. Toed-in perimeter fence/haybales should remain at this site until the growing season. 1/12/06 |

115kV (Rt. 58): Photo shows the Putnam Park storage area where silt fence was righted and snow piles were pulled back as recommended. 1/12/06

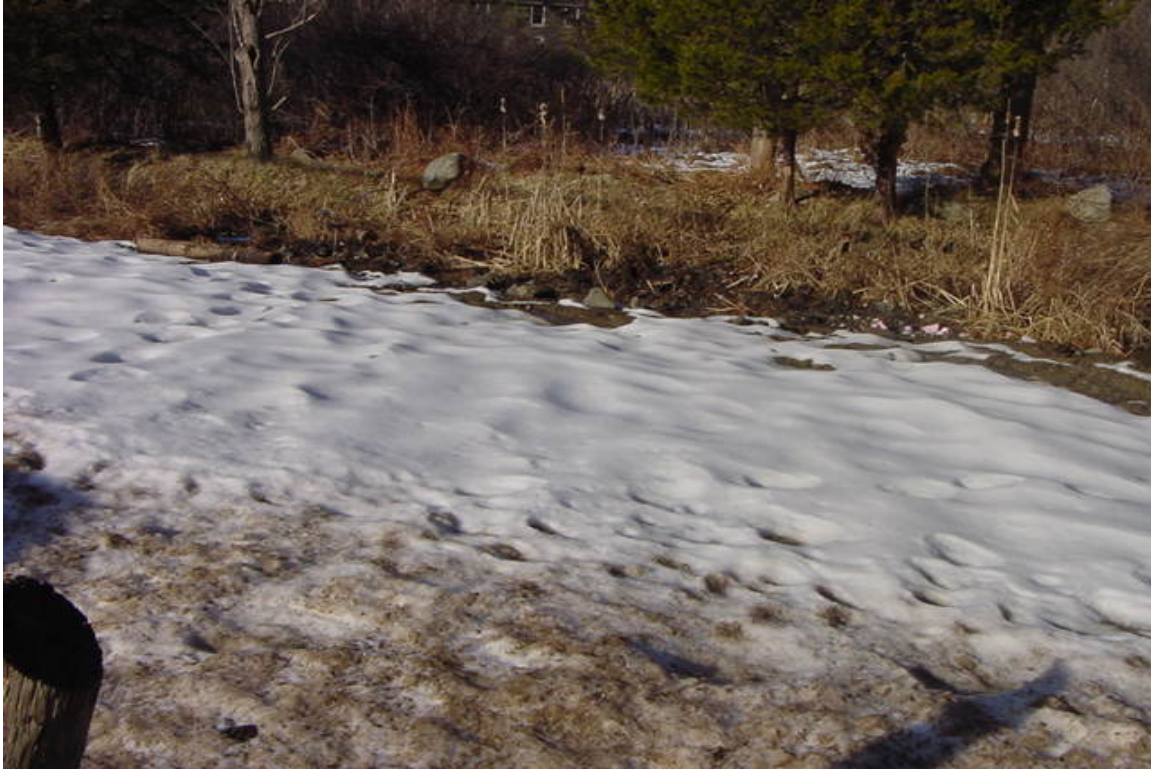
| Areas of Inspection | Observation | Recommended Action |
|---|--|--|
| | -The Sunset Hill Rd. storage area remained partially snow covered but previous issues remain. The contractor will be addressing this area soon. 1/12/06 | - There will be no chance of vegetative stabilization until the growing season, we recommend that that silt fence or haybales remain here- or the area should be well mulched as soon as there is snow melt. Soil should be shoveled out of the swale if feasible. 12/22-1/12/06 |

115kV (Rt.58). Photo shows a view of the Sunset Hill Rd. storage area. Erosion controls are still needed here as a proactive measure. Contractors will be performing some additional restoration here soon. 1/12/06

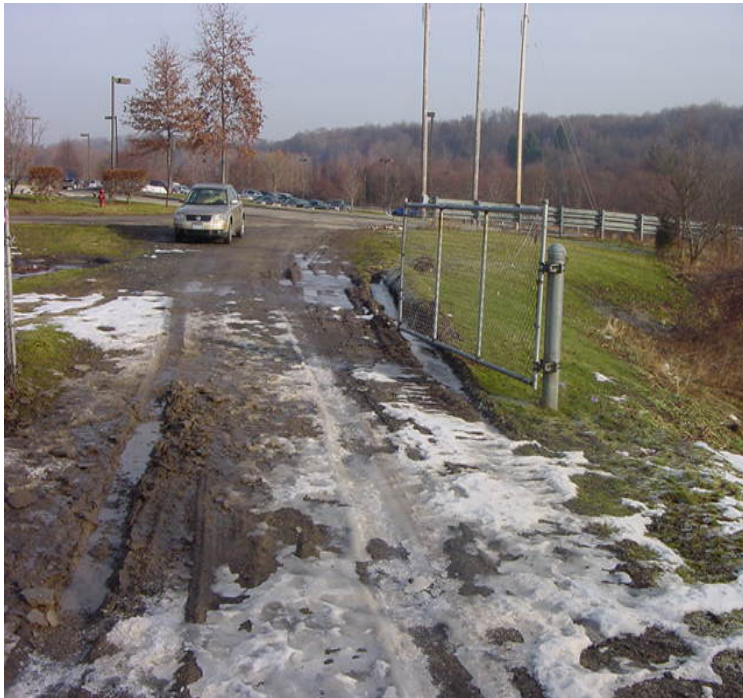
| Areas of Inspection | Observation | Recommended Action |
|---|--|--|
| Erosion and Sediment Controls (includes inspection within 24 hours of a storm event) | - Both portions of the ROW remain fairly rutted under the partial snow cover. 12/1-1/12/06 | -Ruts should be repaired and straw mulch should be placed when access needs are complete. Snow and thaw periods are now a factor.12/8-1/12/06 |

115kV (Bethel Ed) Work is inactive but some attention will be needed in the spring. Photo on the left shows some ruts remaining in the ROW access road and photo on the right shows the small area that continues to wash out regardless of efforts to stabilize. 1/12/06

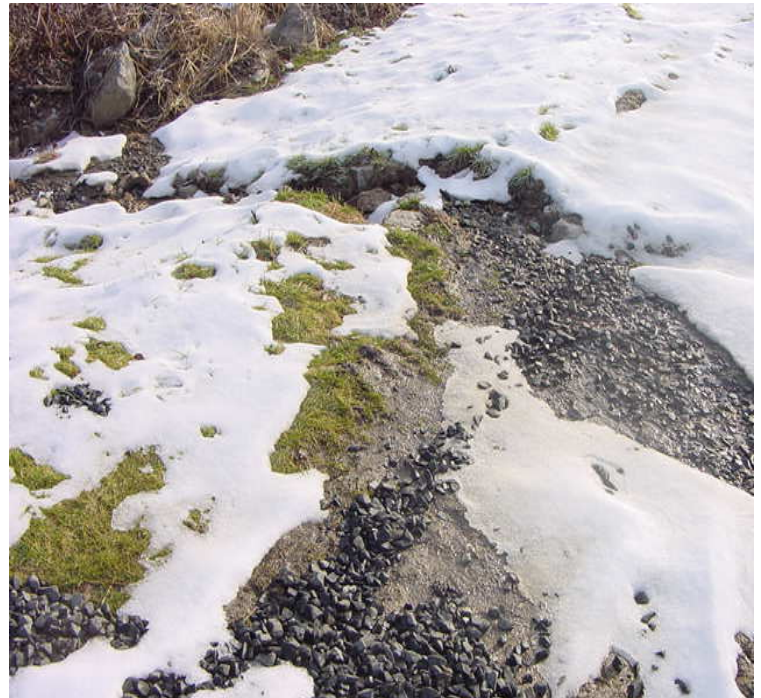
| Areas of Inspection | Observation | Recommended Action |
|---|--|--|
| Bethel Educational Park | -The small, typical washout/gully areas remain on both portions. 12/8-1/12/06 | |
